UNEXPECTED INRUSHES INTO A SMALL MINE

A. E. COBB

ABSTRACT

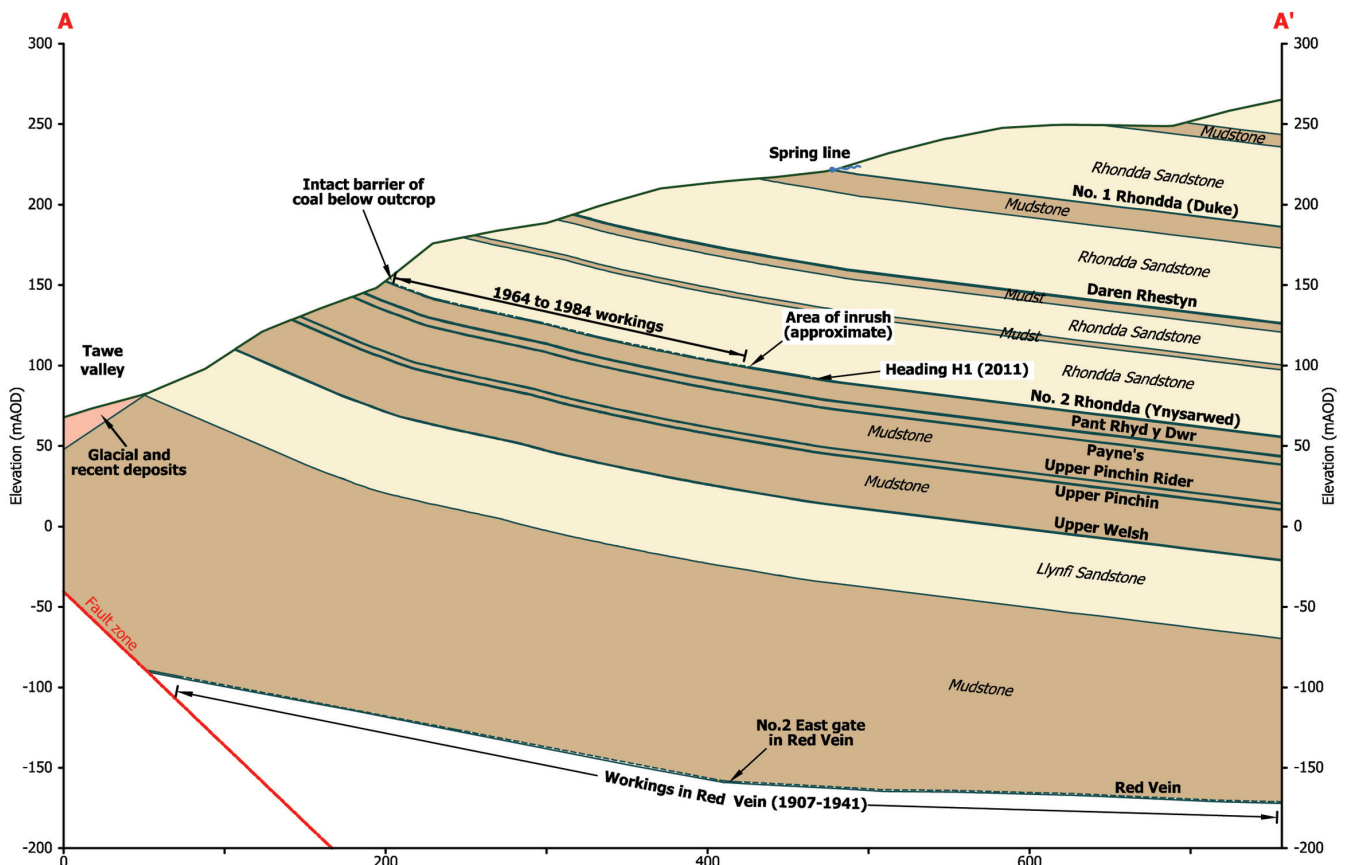
south-east some 55m. Outcrop patterns indicate a substantial 1km sinistral movement as well (Strahan et al, 1907). The mine lies on the eastern side of the disturbance, with the seam dipping at 1 in 4 into the hillside, flattening off as the seam was followed down dip to the east. This is shown by the cross section through the mine in Figure 2.

Figure 2. Cross section through the mine at the inrush location showing coal seams and sandstones. The line of cross section is shown on Figure 1.

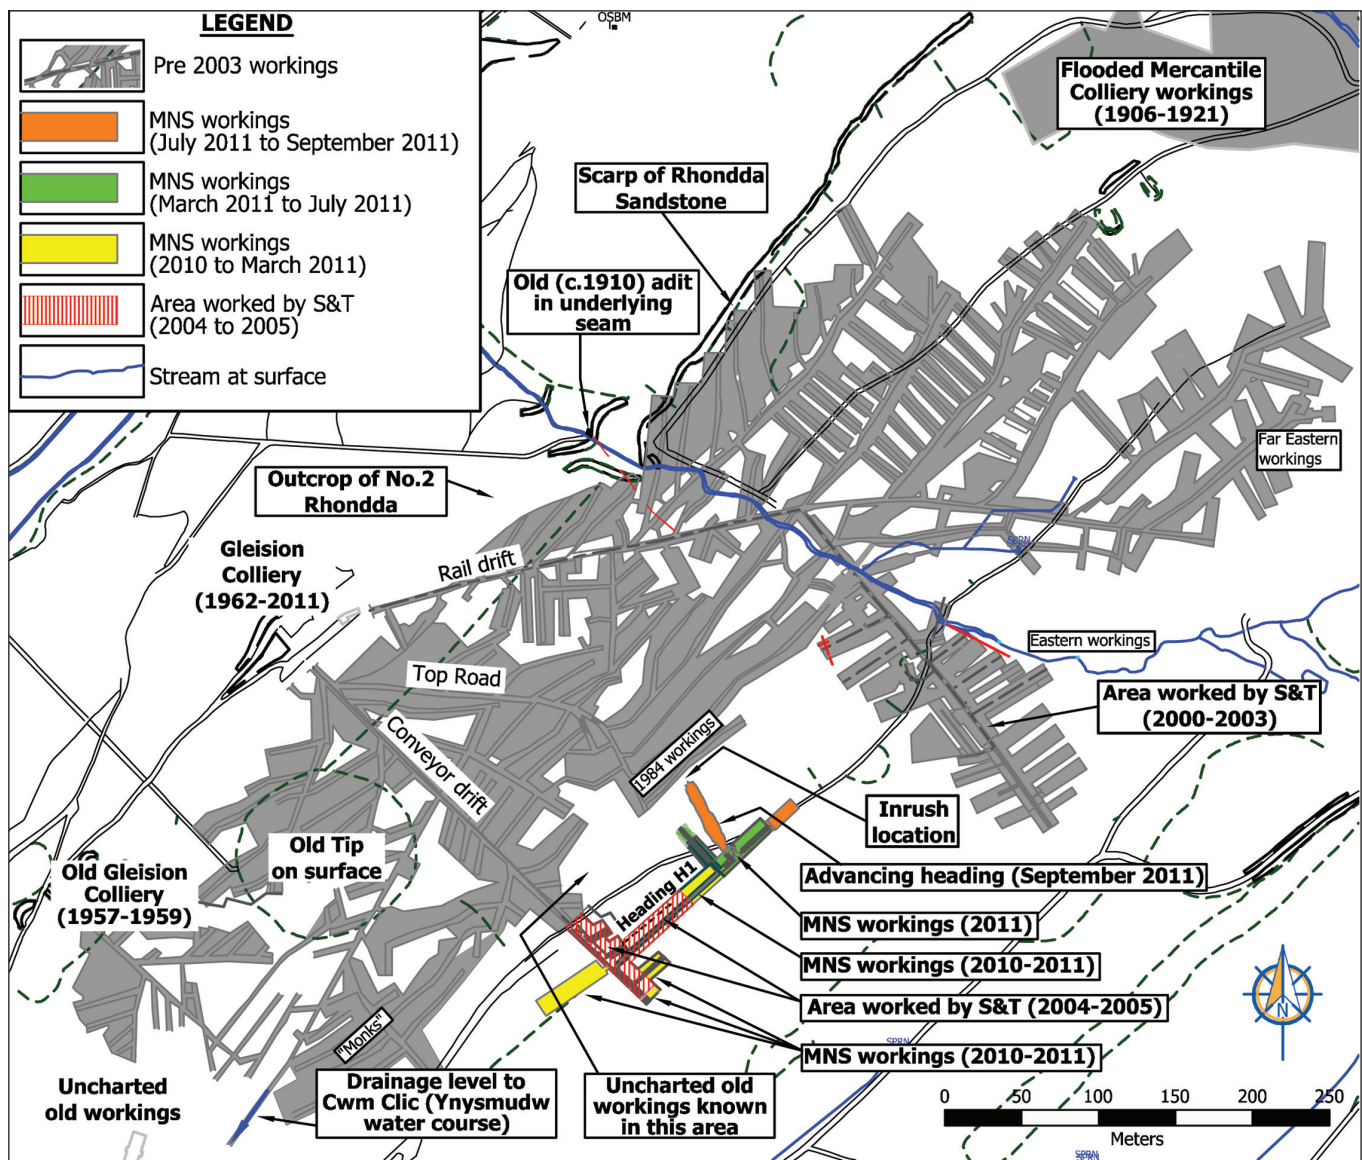
from a heading known as Top Road which branched off to the north of the Conveyor Drift (see Figure 3). It was these 1984 workings that were intersected in the inrush incident.

Figure 3. Mine plan showing working areas in the mine and inrush location.

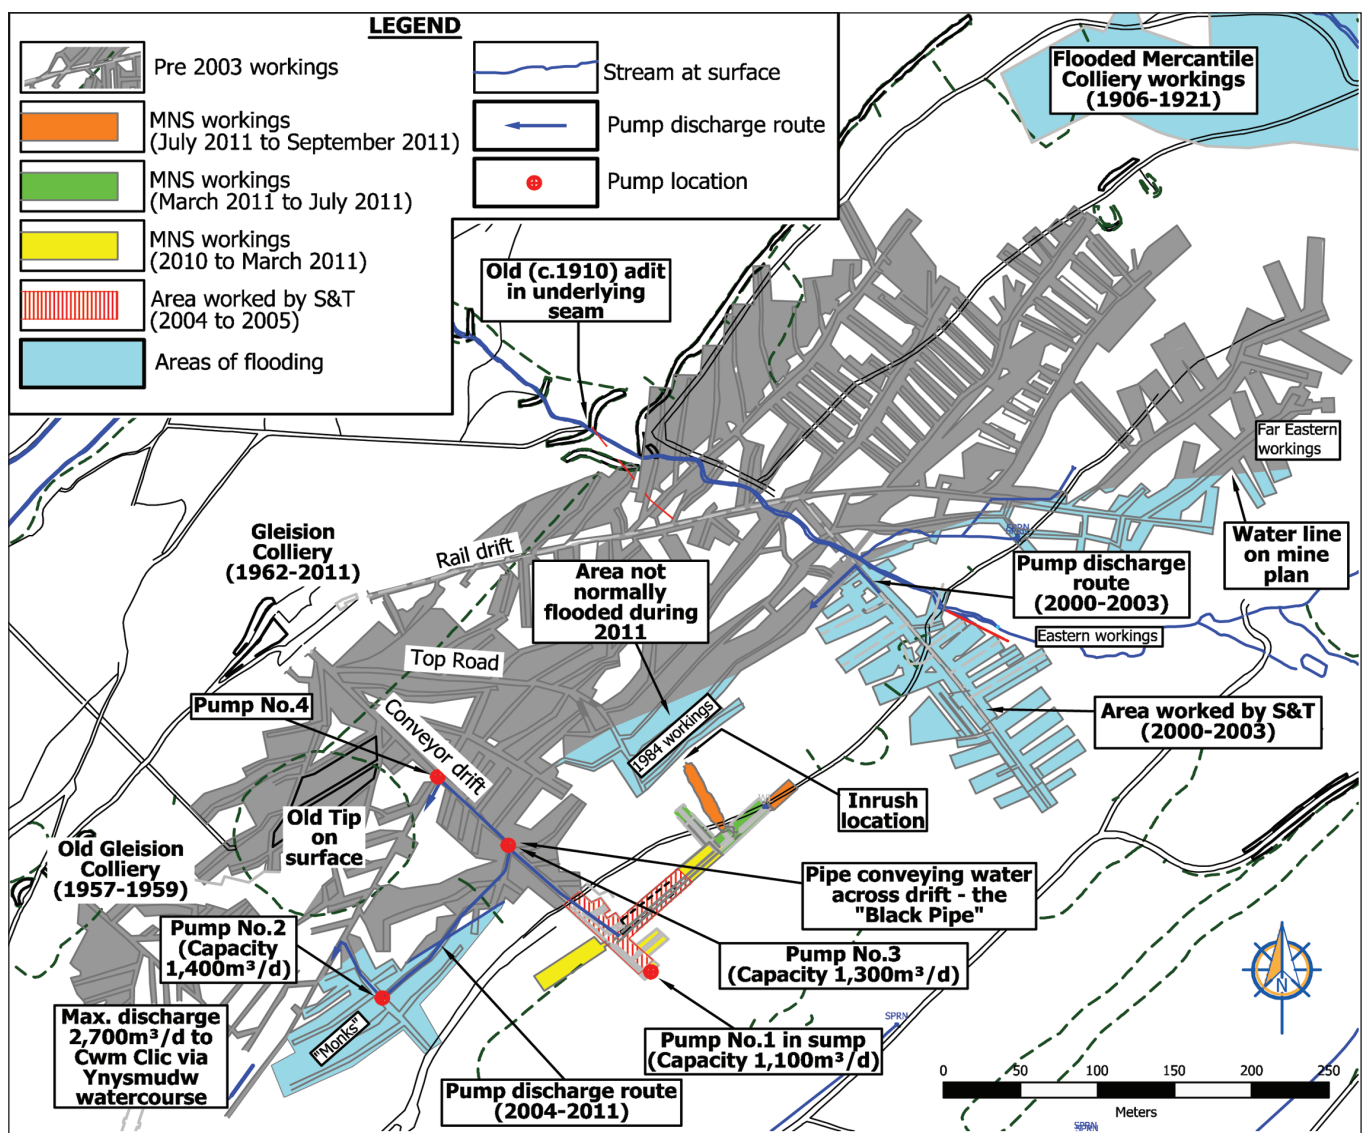
During all of the MNS period, dewatering was primarily by a submersible pump located in the sump of the Conveyor Drift (Pump 1 on Figure 4). This had a capacity of 1,100m³/day and pumped up to the level of the 'Monks workings' (actually workings of 1970s vintage), at c.105mAOD (the location of the Black Pipe shown on Figure 4), some 30m above the sump. In wet weather, this pump had to work for 24 hours a day. There was another pump in the Monks workings (Pump 2 on Figure 4) at a level of c.95mAOD pumping water up to the Ynysmudw water course at a level of c.108m AOD. When MNS took over, these were the only two pumps in the mine. MNS added a further two pumps in the Conveyor Drift, one by the Black Pipe (Pump 3 on Figure 4) and one at the junction of the Conveyor Drift with the connection to the Ynysmudw water course (at about 120mAOD; Pump 4 on Figure 4). Pump 3, by the Black Pipe, was to lift water from the Black Pipe level (the

Figure 4. Pump locations and capacities in 2011 just before the incident.

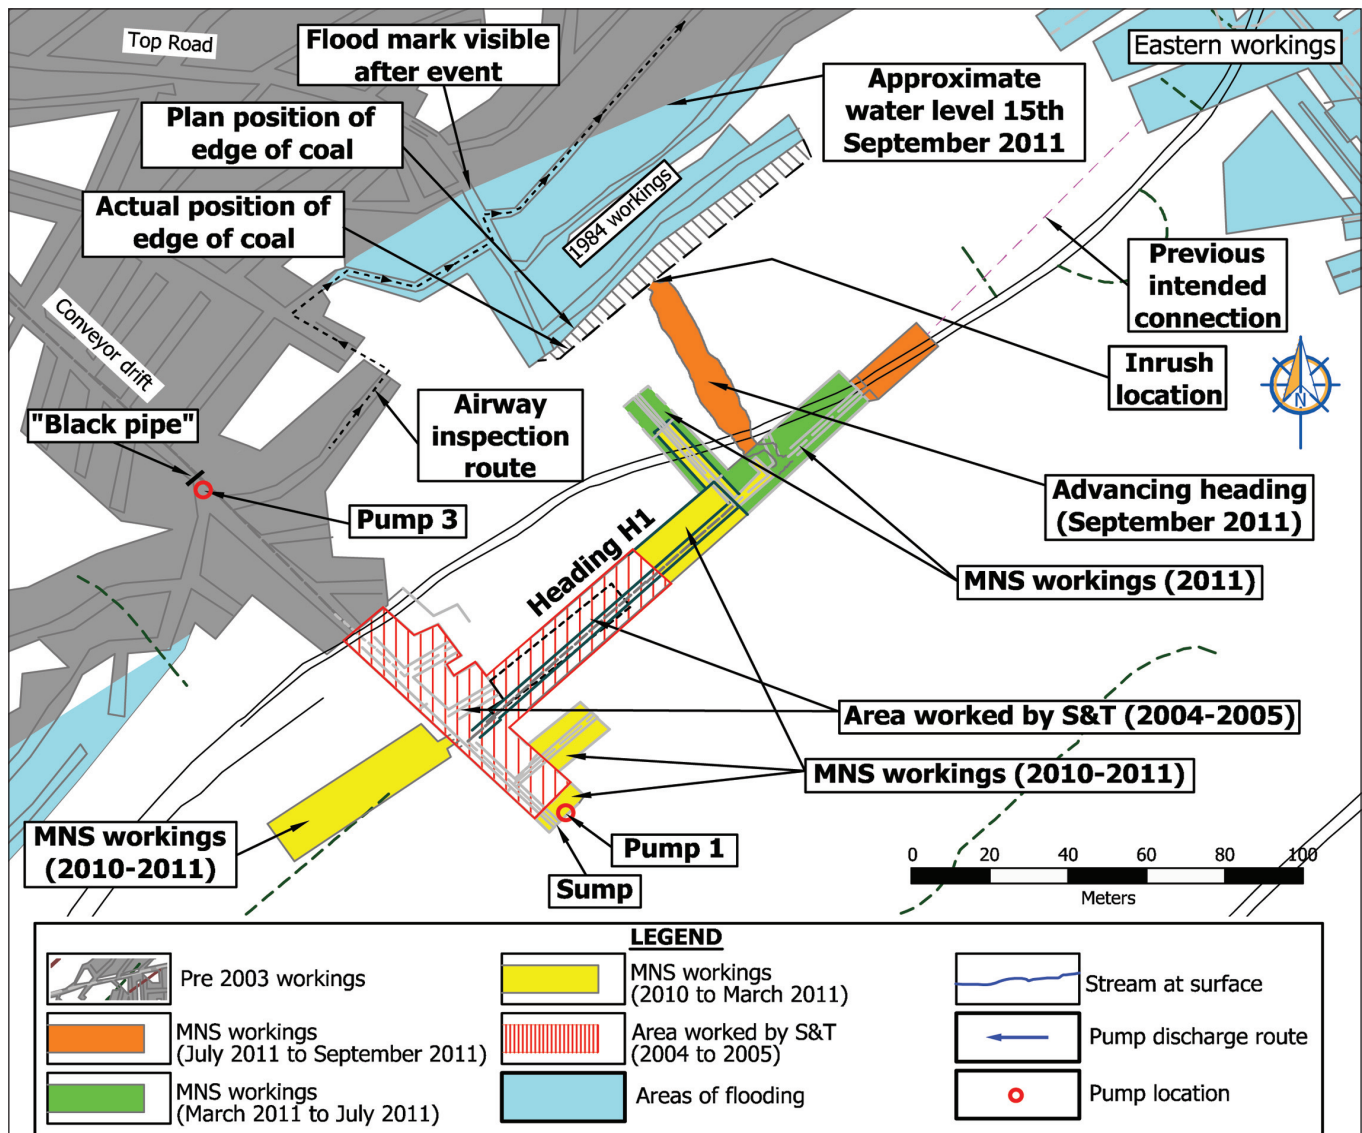
Figure 5. A more detailed plan of the area of the inrush, showing the location of the workings, the presumed area of flooding on 15th September 2011 and the inspection route employed by previous manager to inspect the airway.

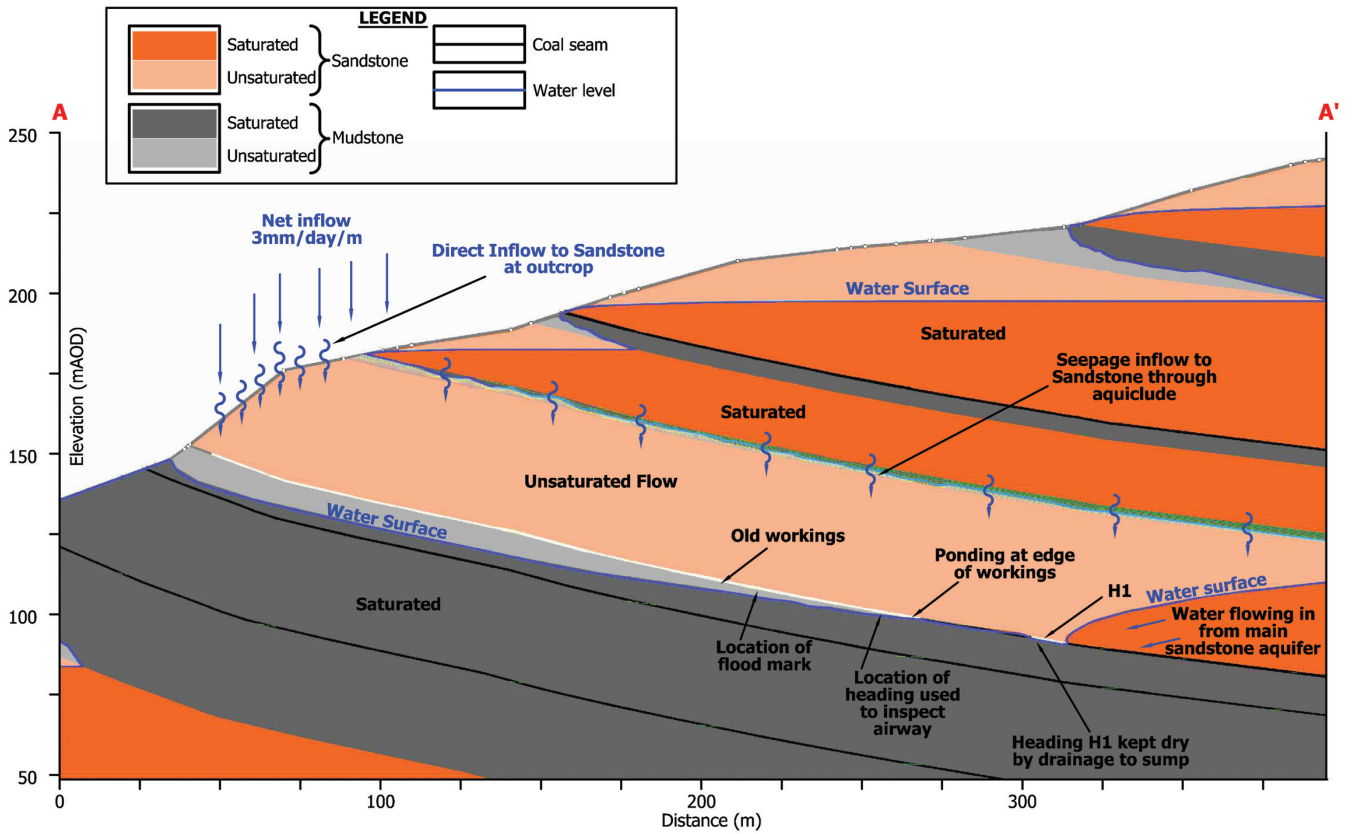
Figure 6. Cross section showing negligible flooding of old workings with a net inflow of 3mm/day/m of outcrop, and an approximate pumping rate of 650m³/day.

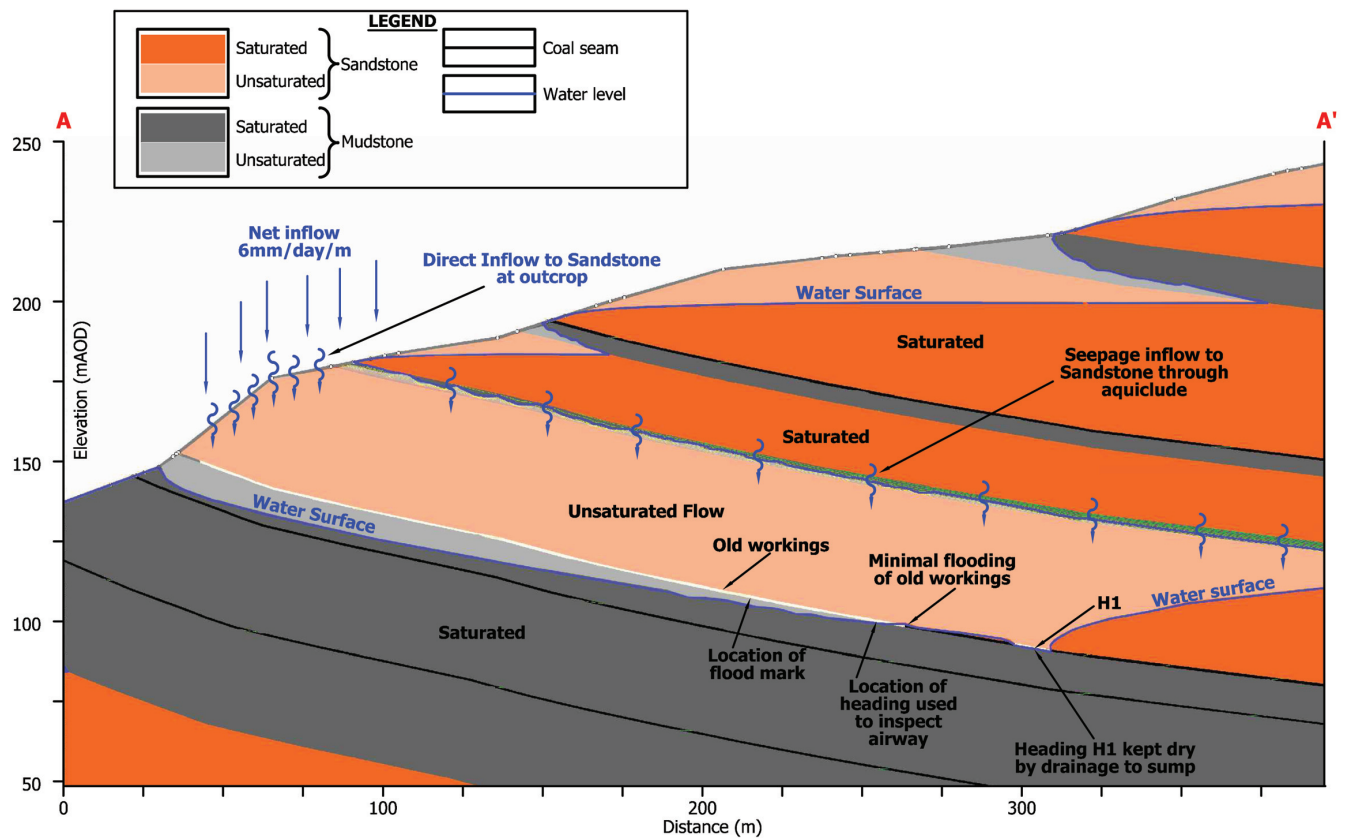
Figure 7. Cross section showing minimal flooding (to c98mAOD) of old workings with a net inflow of 6mm/day/m of outcrop, and an approximate pumping rate of 690m³/day.

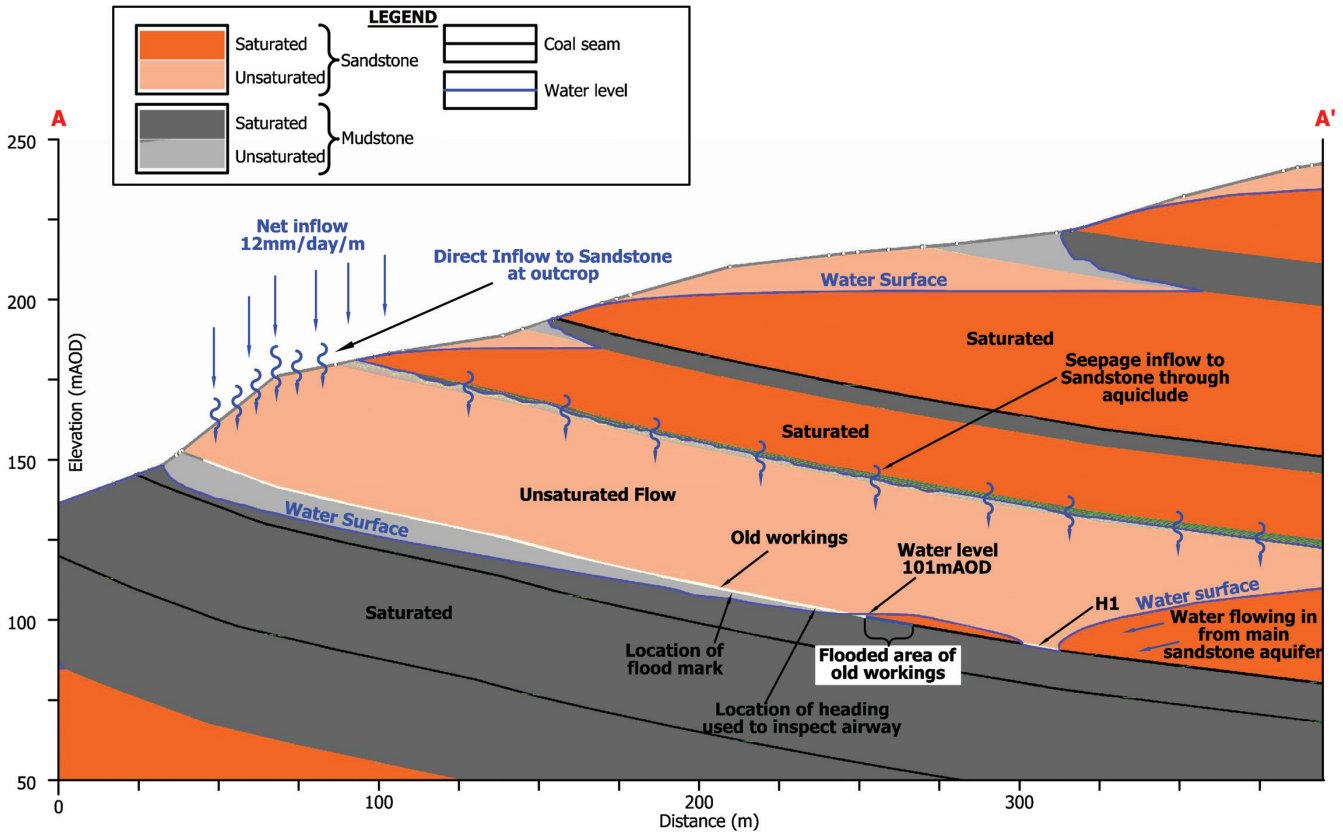
Figure 8. Cross section showing flooding (to c101mAOD) of old workings with a net inflow of 12mm/day/m of outcrop, and an approximate pumping rate of 750m³/day.

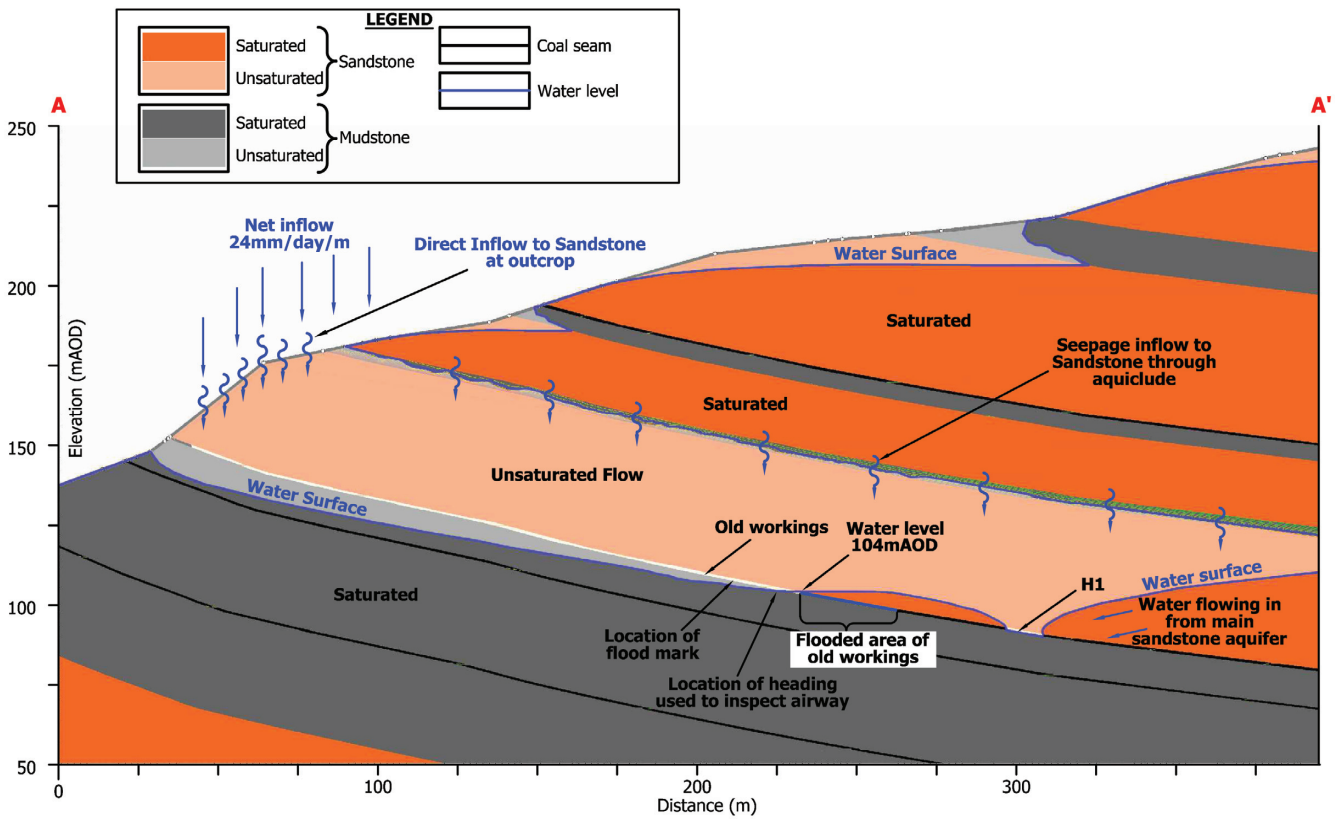
Figure 9. Cross section showing flooding (to c104mAOD) of old workings with a net inflow of 24mm/day/m of outcrop, and an approximate pumping rate of 870m³/day.

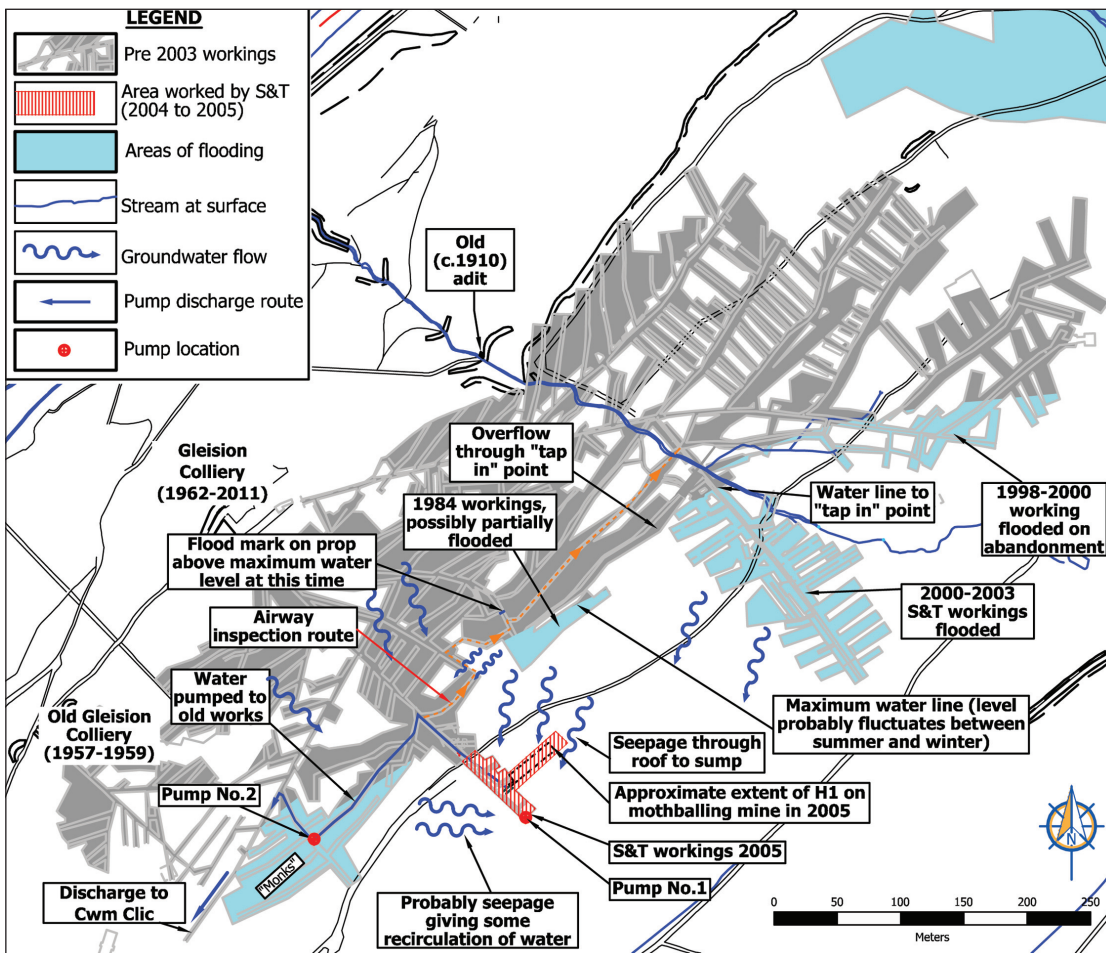
Figure 11. Water conditions in mine, 2004 to 2005.

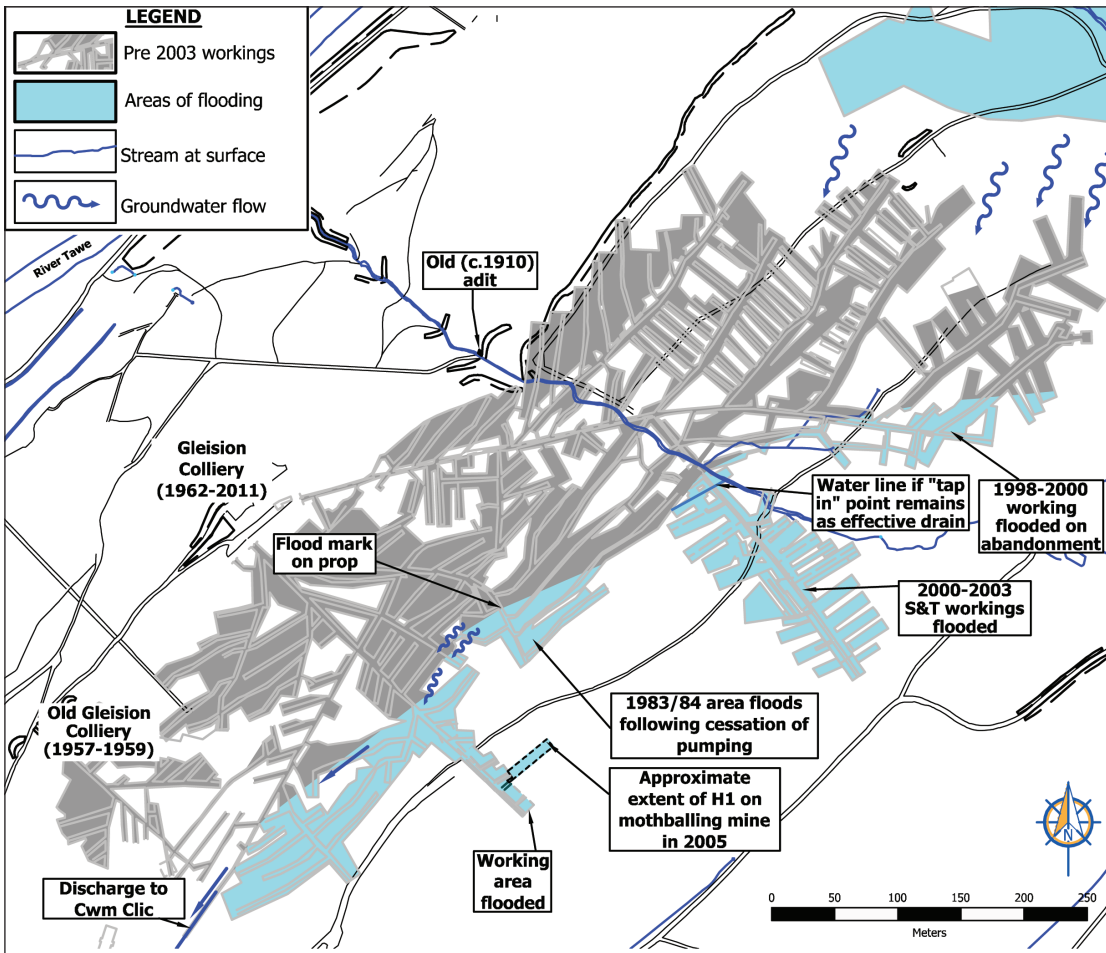
Figure 12. Water conditions on mothballing in 2005 to 2008.

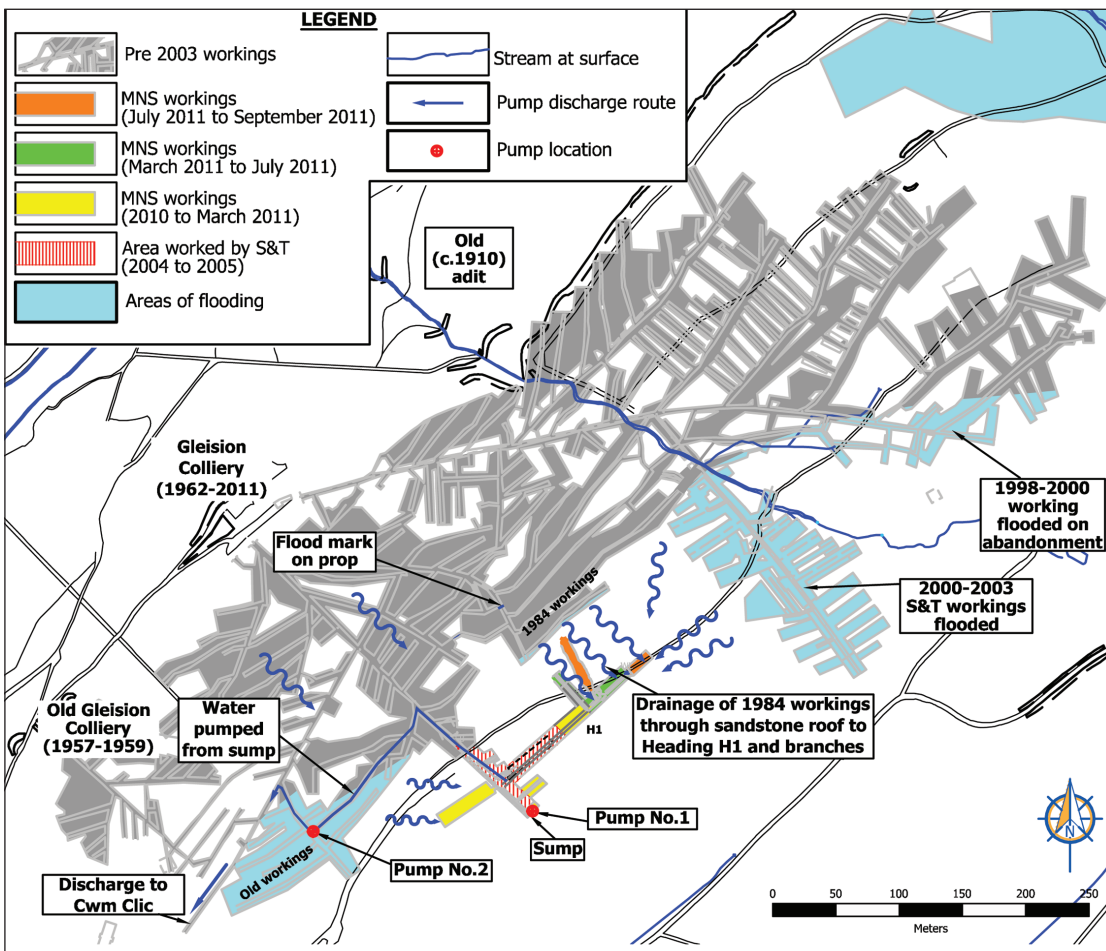
sough (Figure 10) of the Ynysmudw watercourse. Water levels in the 1984 workings would consequently have been about the flood mark observed. In 2003, there was no down dip passage into which the water could flow. But, with the advance of the down dip strike heading H1 in 2005, the hydrogeological regime changed. After the driving of H1, the water had somewhere to go, and at least partial drainage of the 1984 workings could have occurred, as shown in Figure 11. When the mine was mothballed in 2005 and allowed to flood, water levels would again have risen to the level of the flood mark observed in the 1984 workings (see Figure 12). From 2010 to 2011, with renewed pumping and driving forward of H1 and at least one crossheading 20-30m up dip, drainage of the 1984 workings would again be possible, leading to the situation shown in Figure 13, which is consistent with what the manager claimed to have observed.

Figure 13. Water conditions August to early September 2011.

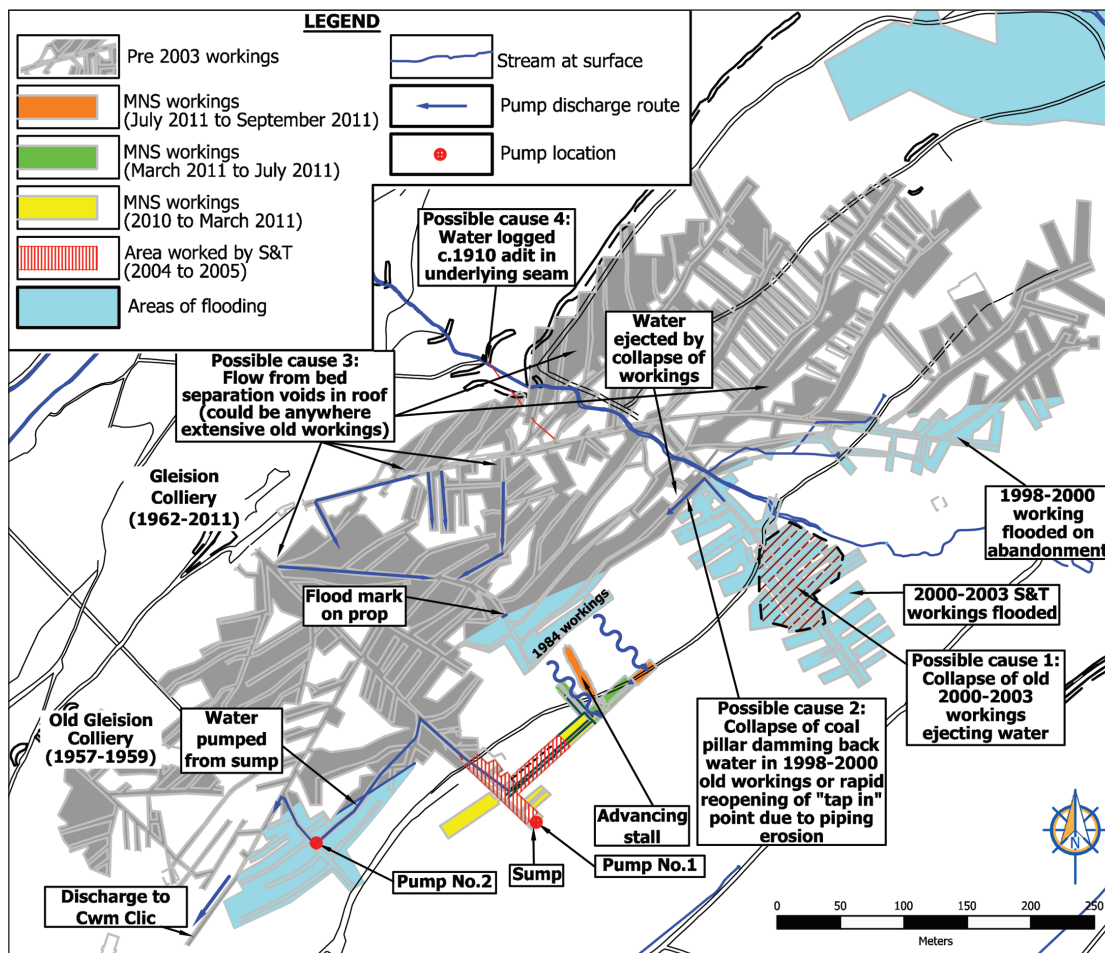
Considering the flooded 2000 to 2003 S&T workings, the stability of many of the pillars are highly suspect, especially in the area shown in Figure 14. The author computed the stability of the pillars using the empirical method of Salamon and Munro (1967), with the required adjustments to convert square to rectangular pillars given by Hsiung and Peng (1985) (rectangular pillars are weaker than square pillars of the same cross sectional area). The results showed many pillars with Factors of Safety below 1 (and therefore very likely to fail) and many more with a Factor of Safety less than 1.6 (which may fail eventually). The thick seatearth would also be liable to soften with prolonged exposure to water (Denby et al, 1982) permitting pit props to sink into the floor, removing any support they might give. (It is recorded that the roofs of at least two of the panels in the 2000 to 2003 workings collapsed whilst the pit props were still present, in one case while the equipment was still in the stall.)

Given that the average thickness of the workings in this area is 0.77m, to provide the pulse of 1,600m³ of water required to fill the 1983/84 workings to the flood mark, overnight, would require the collapse of some 2,000m² of roof. The pillars with Factors of Safety below 1 supported some 4,900m² of roof, so collapse of less than half this area would expel the necessary volume of

Figure 14. Water conditions on 15th September 2011 and some possible sources of water to fill the 1984 workings overnight.

water. The pillars with Factors of Safety between 1 and 1.6 supported a further 1,700m² of roof, with the potential to expel a further 1,300m³ of water.
