SWINDEN QUARRY: A CASE STUDY OF DETECTING, SURVEYING AND MANAGING CAVES WITHIN QUARRIES

C.S. ARDITTO¹ AND M. HUDSON²

ABSTRACT

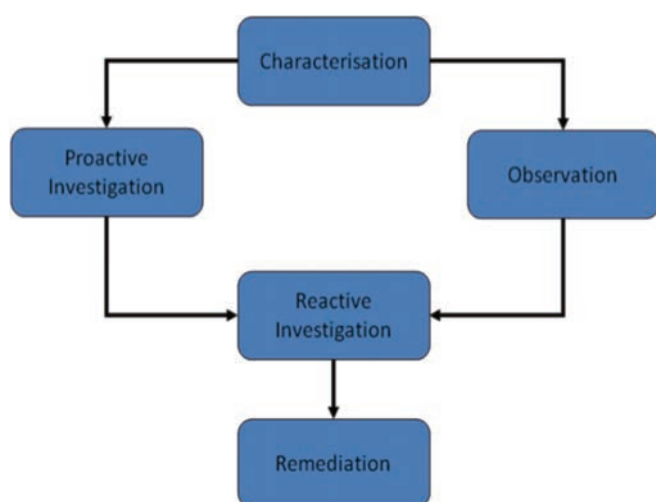
Figure 4. Flow diagram for cave management at Swinden Quarry.

The finding of caves at Swinden is relatively common and the process by which these caves are managed is shown in Figure 4.

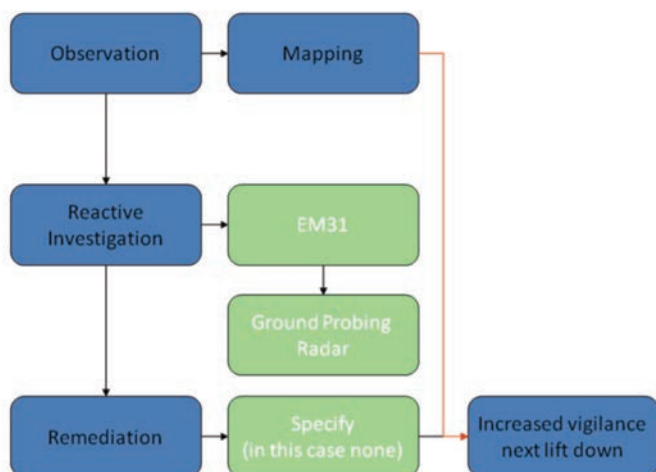
Figure 5. Process map for observational mapping and reactive investigation of cavities at Swinden Quarry (blue boxes). The green boxes show the investigative techniques used.

In practice this means that existing caves are mapped as the faces progress, and that new features are recorded and then investigated. This process is shown in Figure 5.

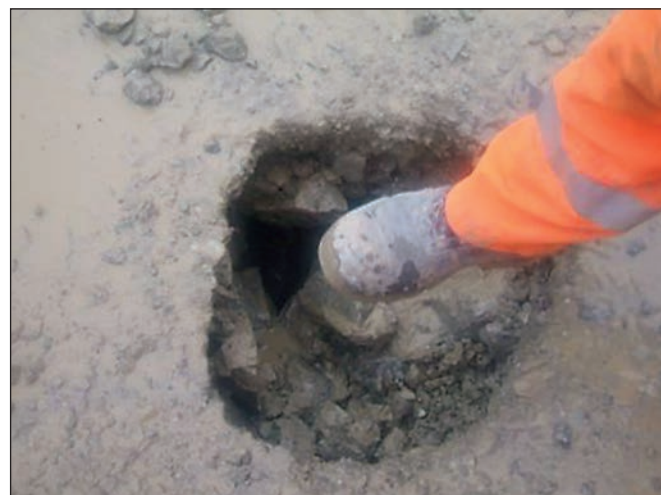
Figure 6. Small cavity on the 155m level, approximately above the location of the large open cave.

In 2010 one such feature was noted on the 155m AOD (Above Ordnance Datum) level at Swinden Quarry. This appeared to be an innocuous feature, as shown on Figure 6. Initial investigation using a dipmeter indicated it in part to be open. As a result further investigative work was undertaken by the University of Leeds using a combination of EM31 electromagnetic and Ground Penetrating Radar (GPR) surveys. A cave c.4m wide at between 1-4m BGL (Below Ground Level) was detected, with the interpretation that the hole was probably infilled with conductive material e.g. clay, as shown in Figure 7. This work also confirmed that the effective depth of these surveys was limited to 4-6m BGL.

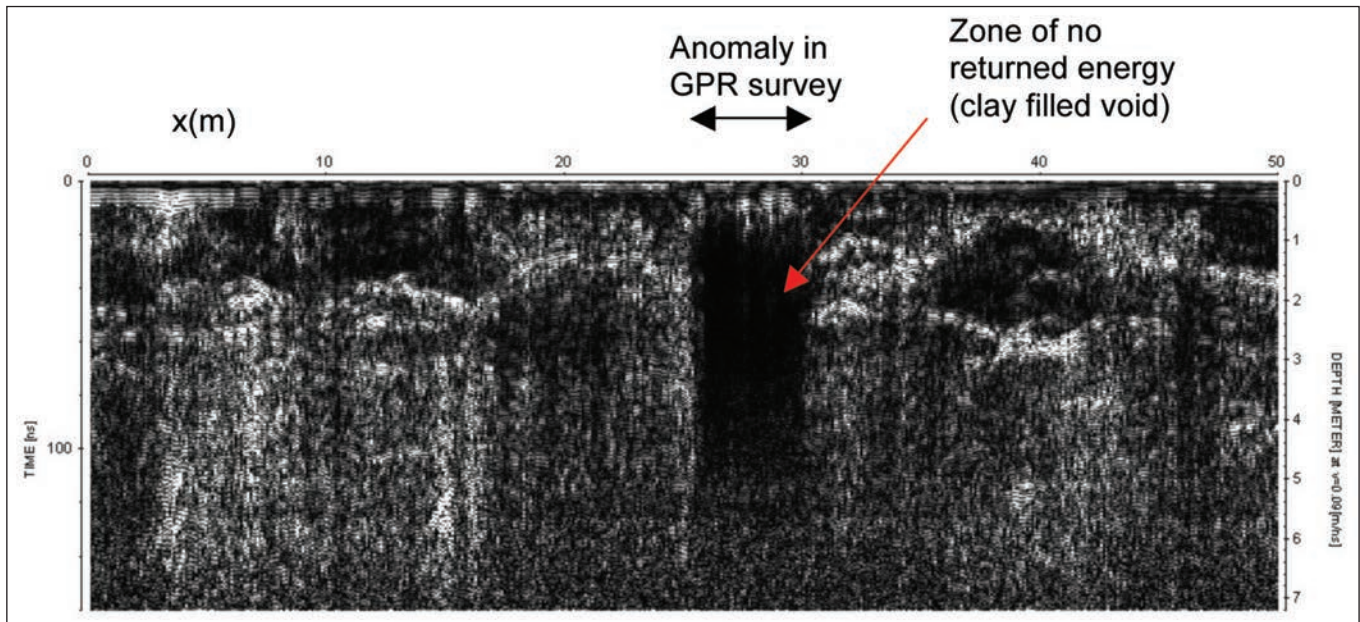
Figure 7. GPR scan to a depth of 7m, conducted following observation of the open hole in quarry floor on the 155 mAOD level.

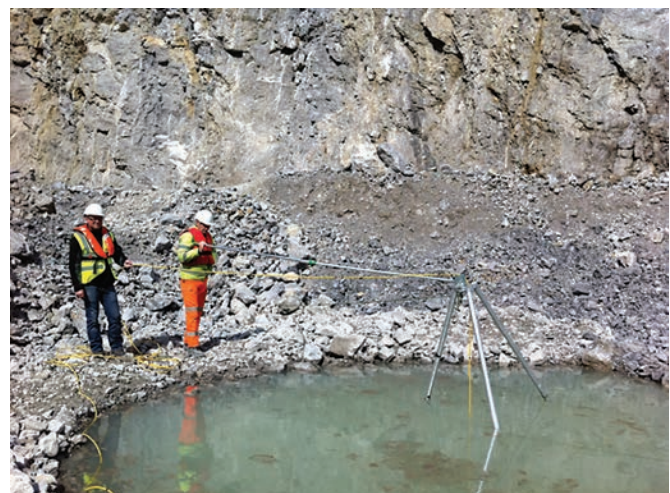
Figure 9. Tripod set-up over the cave opening, with the sonar instrument being lowered via the yellow cable.

Due to the width of the cave entrance, a large, purpose made tripod (Figure 9) was required to ensure that the cave opening could be spanned and to facilitate the lowering of the sonar unit into the centre of the cave.
