THE GEOLOGY OF PENLEE QUARRY, CORNWALL, ITS IMPACT ON PREVIOUS QUARRYING AND FUTURE USE

P.W. SCOTT¹ AND G. WALTON²

Pp. 170-176 in Scott, P.W. and Walton, G. (Eds) *Proceedings of the 15th Extractive Industry Geology Conference, EIG Conferences Ltd, 186pp.*

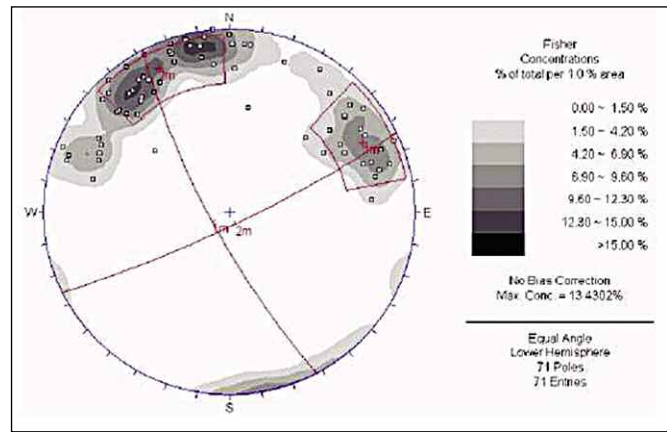
Figure 2. Stereographic plot showing vein orientations at Penlee Quarry and adjacent foreshore (after Denby, 2004).

There is extensive hydrothermal mineralisation in the quarry represented by two distinct sets of veins (Figure 2) along with associated wall-rock alteration. A vertical to sub-vertical ENE-WSW set is represented by thin, up to around 20cm veins hosting a considerable variety of single and polymetallic sulphides and associated minerals with quartz. Pyrite and arsenopyrite are common. Figure 3 shows the detail of a typical vein and Figure 4 shows details of the mineralogy in several veins. A second subvertical set of veins is found with a NW – SE orientation, often called cross-courses, including a major quartz rich multiple vein locally 10-15m across with extensive associated wall rock alteration. This vein crosses the whole quarry (Figure 5). It is presently represented by a promontory on the NW side of the quarry. It contains no sulphide minerals, being made up of several generations of quartz and chalcedony. It splits up on the SE face to form a wider zone and is associated with extensive kaolinisation of the wall rock. A complete list of the minerals found in Penlee Quarry is listed below (excluding those as essential minerals to the metadolerite and Mylor Slates):-

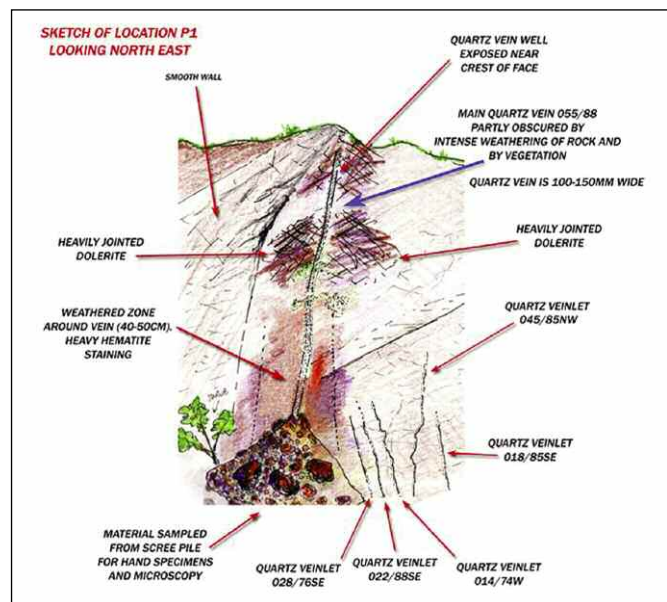
Figure 3. Annotated sketch of the key features found in a typical ENE-WSW vein (from Denby, 2004). The bench height is approximately 10m.

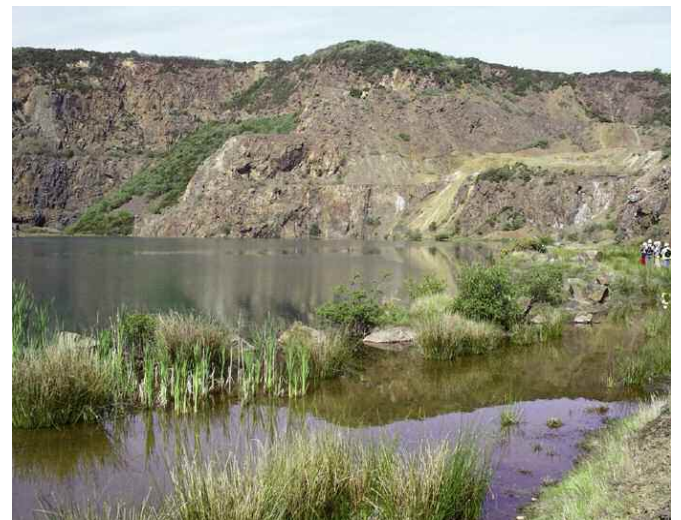
Figure 5. Part of the quarry with the centre of the photograph showing a promontory that includes a large composite NW-SE quartz vein with attendant kaolinisation. The quarry sump has subsequently been lowered by 9m.

groundwater rebound, but more probably ponding of surface water, had occurred. The workings were flooded to a level of 10m AOD and the slopes were in a poor condition with frequent rockfall and many inaccessible sections of the quarry (see Figure 5). A period of 14 months of clearance operations and face scaling were necessary before more detailed investigations could be undertaken and an adequate quarry survey prepared. There were no available pre-existing quarry surveys, the Health and Safety Executive having preserved no records relating to previous quarry workings and Ordnance Survey data was totally inadequate. It was decided to compile a complete record of available terrestrial photographs and air photographs. The earliest terrestrial photographs are dated 1910, in the British Geological Survey archives, and the earliest air photographs are dated from 1917, having been taken by the Royal Naval Flying Corps.

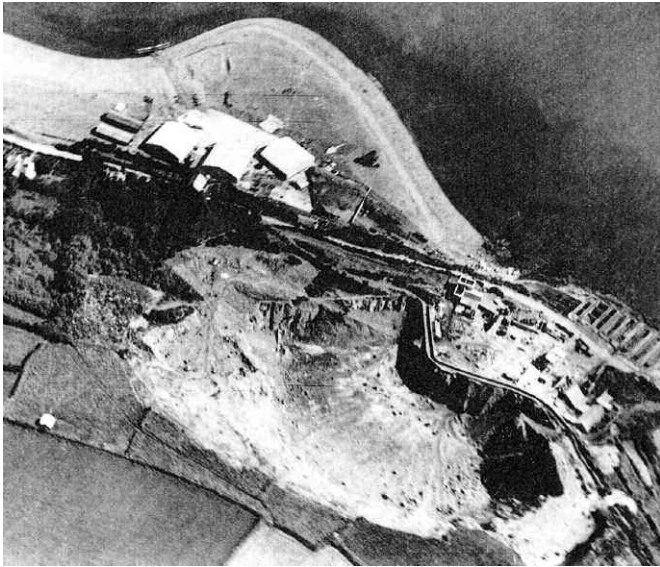
Figure 6. Royal Naval Flying Corps air photograph of Penlee Quarry workings and adjacent naval air station in 1917. Note the diverted Newlyn – Paul road between the main quarry workings and the processing area on the right hand side. The remains of the road and the archway connecting these workings are shown on Figure 11.

shown in Figure 6. By 1936 the quarry faces were 60m-70m high and un-benched and the workings covered an area of 9ha. Waste, including top and sub soils, appears to have been tipped to the north of the quarry and extensions seem to have been based on the regular acquisition of separate fields with no particular geological constraints. There were many accidents resulting from the methods of quarrying, since benching does not appear to have been developed until the late 1930s.

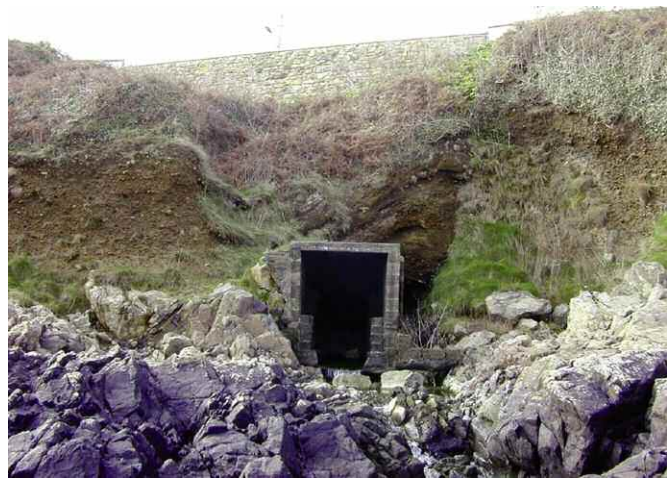
Figure 7. The 1948 adit used for discharging surface water collecting in the workings. This adit passes under the Newlyn – Mousehole road onto the foreshore. The adit lies near the proposed breakthrough to the sea.

Shortly after the Second World War workings had extended to cover more than 15ha and had been deepened below sea level. No significant groundwater seepages were reported, but the catchment was such that discharge was important. In 1948, a small shaft was sunk with an adit driven onto the foreshore (see Figure 7). With pumping this permitted future workings to extend to a depth of about 30m below sea level. Although the metadolerite was jointed with variably spaced joints in up to 6 principal joint sets, the joints were tight and there has never been any indication of seawater ingress. However by the 1960s the 90m high western faces had been split into benches of 45m, 23m and 22m in height and the existence of the significant NW – SE quartz cross course noted above had been identified. The presence of kaolinite on either side of the network of quartz veins made this material unsuitable for aggregate production and a promontory of ground was left unexcavated. By the 1950s the quarry had become a major source of road stone both in England and Northern Europe. Since the early years of the 20th Century a narrow gauge railway had conveyed stone to Newlyn South Pier for shipment even though the harbour was tidal and only small vessels could be loaded (see Figure 8).

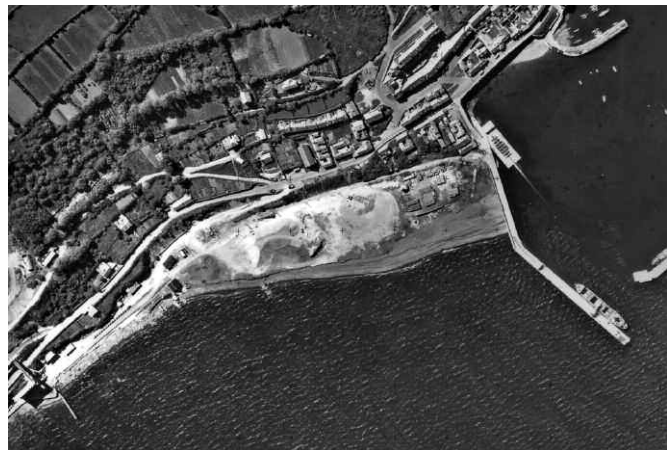
Figure 8. An aerial view of the main shipping arrangements for the export of aggregate circa 1970 showing two trains carrying tubs to a vessel at Newlyn south pier. The local road network includes several pinch points with road widths of less than 4.5m compounding export problems.

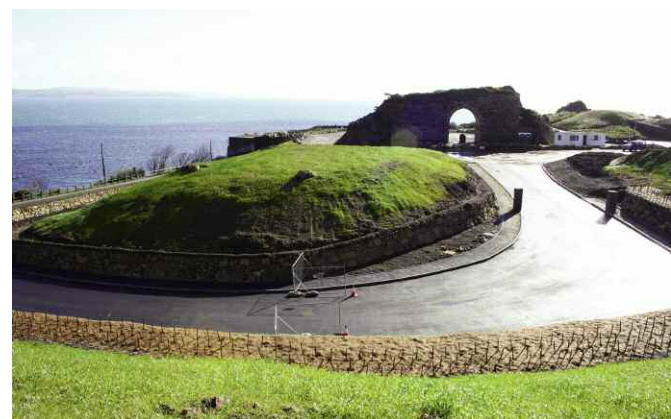
Figure 11. The new quarry entrance just prior to completion showing the archway that formerly carried the Newlyn – Paul road. The elevated ground in front and to the left of the archway comprises mainly metadolerite whereas the road runs through former quarry backfill.

breaking. Additional problems then arose when a massively reinforced underground reclaim structure was found embedded in the fill that also required breaking. The initial and subsequent routes are shown on Figure 10 and the completed road into the site is shown on Figure 11.

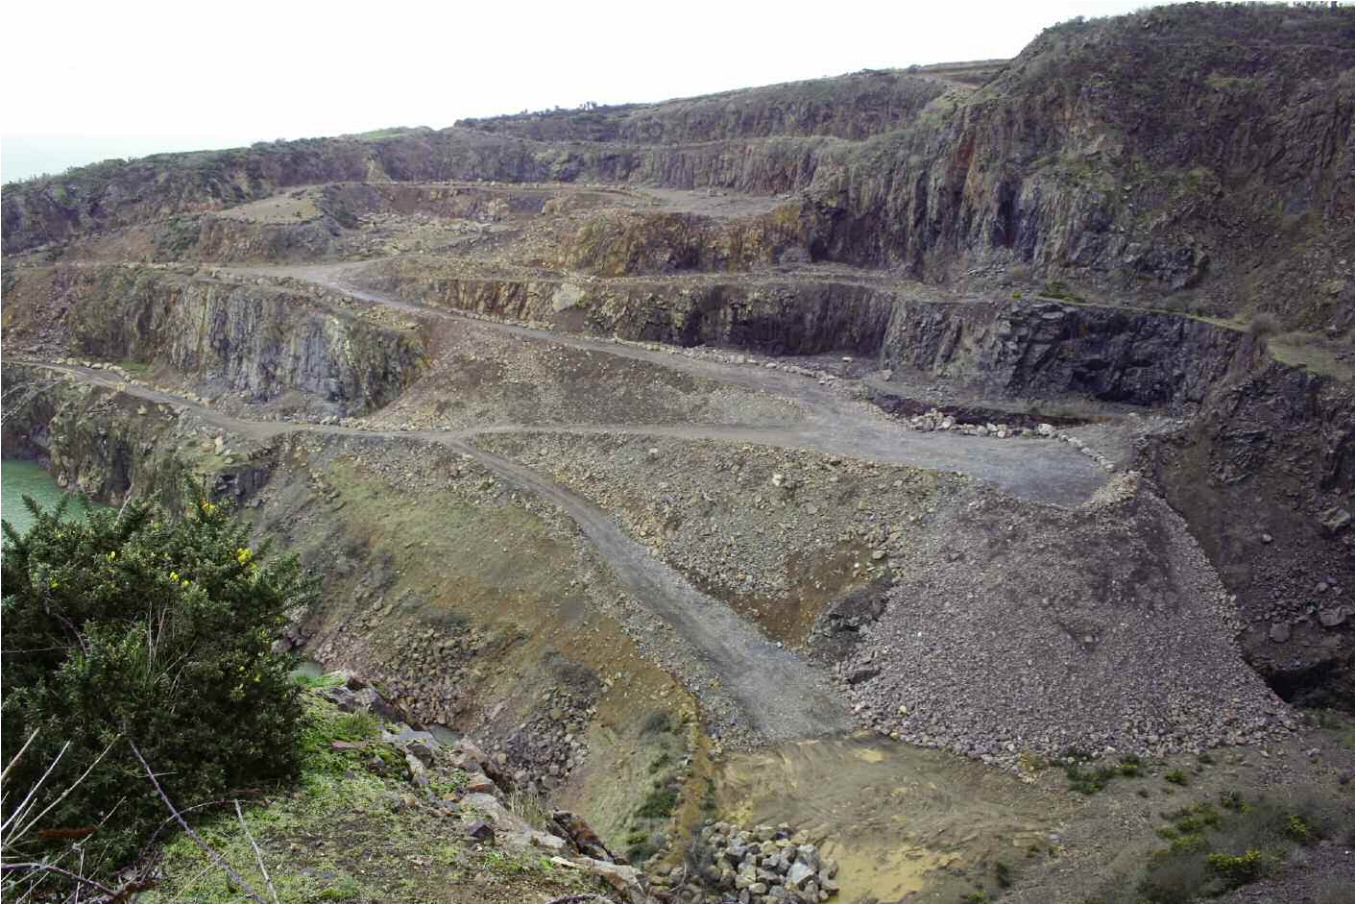
Figure 12. A general view of the proposed armourstone quarry benches looking SSE immediately after the removal of unexploded explosives.

The location of the proposed armourstone quarry is shown in Figure 12 and its initial development is under way. Unfortunately a previous quarry operator had a series of misfires that were buried and concealed. These left a number of unexploded explosives including detonators and primers that remained live. A further scheme was required to enable the recovery/destruction of these explosives; this has now been completed.
