UNEXPECTED INRUSHES INTO A SMALL MINE

A. E. COBB

ABSTRACT

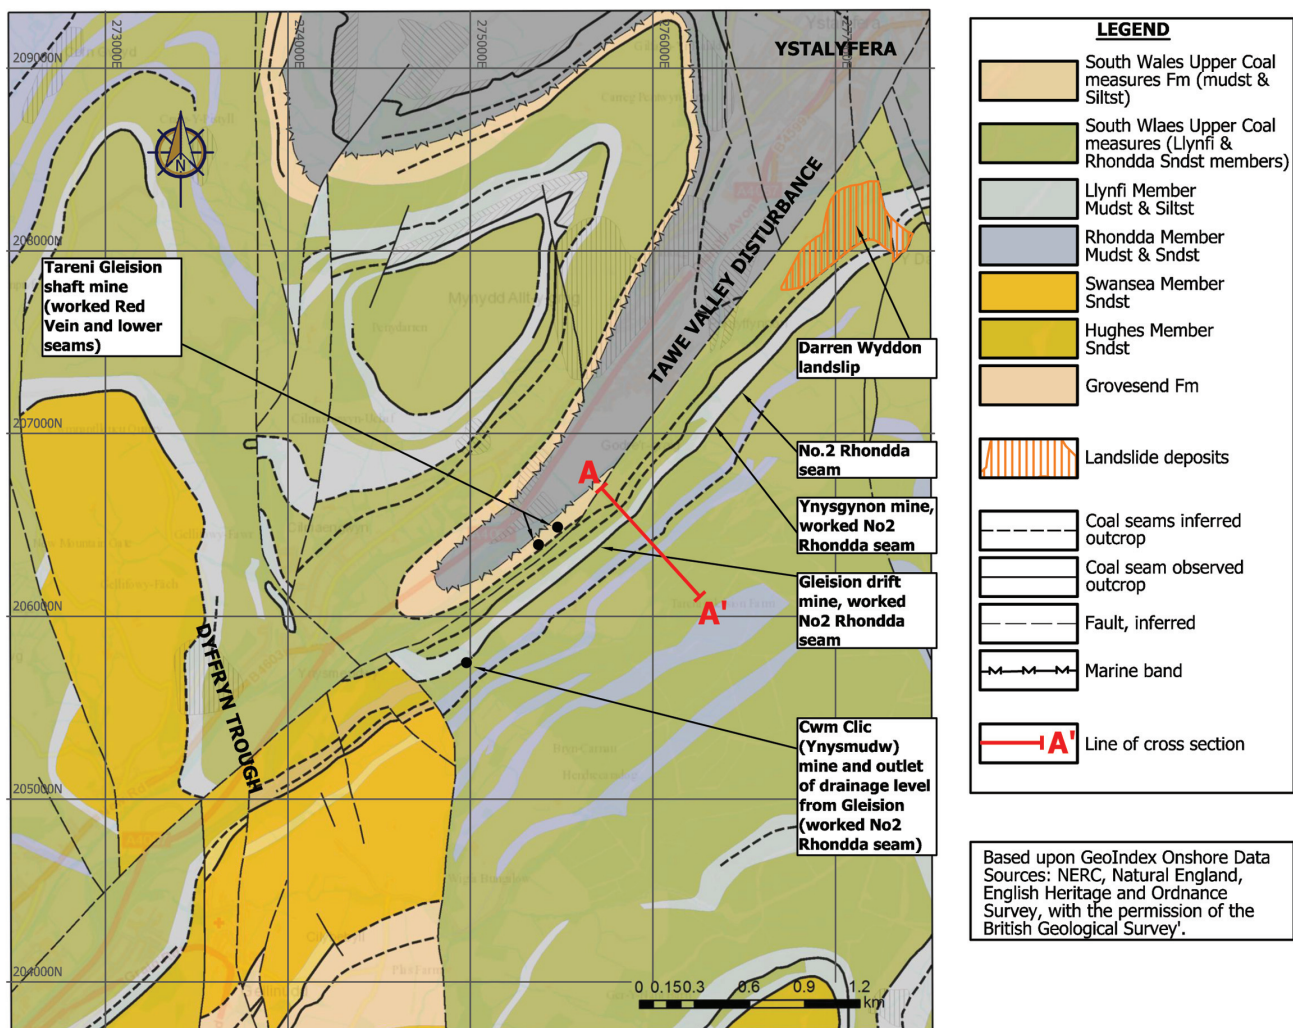
The mine entrance is on a steep wooded hillside forming the south-eastern side of the Tawe valley, between Pontardawe and Ystalyfera, in the western half of the South Wales Coalfield, see Figure 1, and between Swansea and the Brecon Beacons National Park. Surface access to the mine was very poor, at the end of a 2km long, narrow, single carriageway road with very few passing places. This access road severely limited the possible output. The mine worked the No. 2 Rhondda seam (known as the Ynisarwed in this part of the coalfield), which was about 0.7m thick at outcrop and was worked from an adit ('Conveyor Drift') running down dip in a south easterly direction.

Figure 1. Extract from BGS 1:50,000 map showing location of Gleision mine and surrounding mines. The line of cross section A-A' is shown, the corresponding cross section is on Figure 2.
